UNITE HERE! Local 11

February 6, 2023

Re: Employee Safety Complaint - Obstructed Exits at Flying Food Group Facility at 901 W. Hillcrest Blvd. in Inglewood, California

Allegations of Cal/OSHA General Industry Safety Order Violations re Shuttered Exits

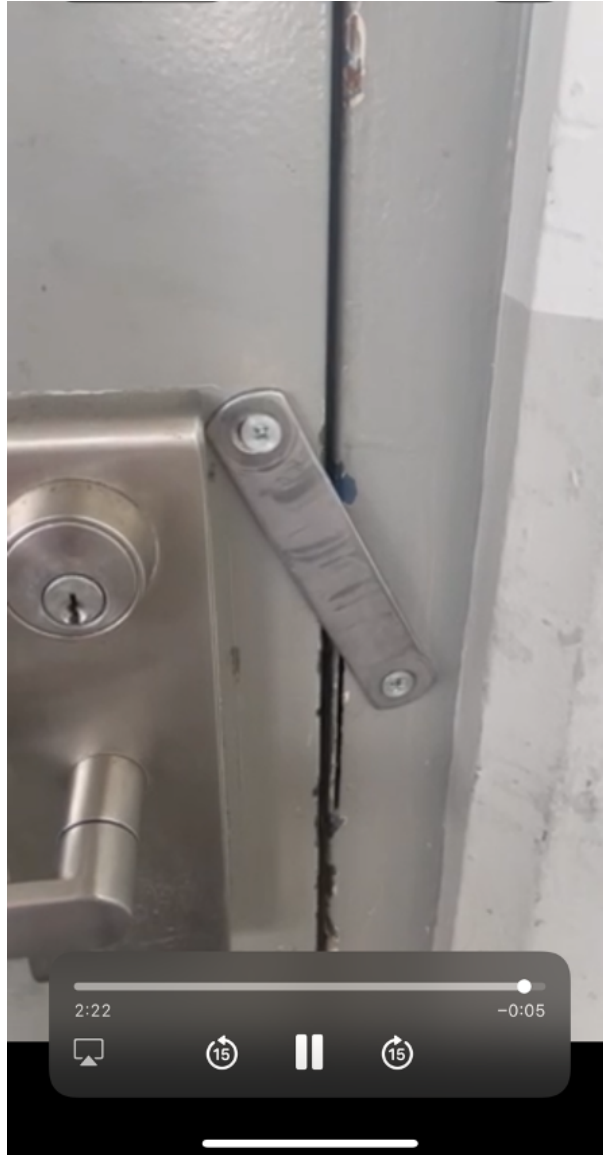
Mark Holguin, a driver employed by FFG, approached Perez and Ramirez while Ramirez was on the phone with Vargas. Holguin announced that a screw plate had been drilled into the wall and the door, which made it impossible for employees to open the exit from the inside. Perez walked outside and confirmed that a metal plate had been bolted to the outside of the door. Perez stated that she was going to call the fire marshall.

A photo of the dispatch door bolted shut is provided below (it is a screenshot from a video taken by Perez, which we would be happy to supply Cal/OSHA).

Around 10:53 AM, Salvador Sandoval, a maintenance employee, arrived and removed the screws from the door at the request of Ramirez. Perez asked him if he had been the one to install the metal plate. He nodded.

Perez called the fire department around 10:45 AM. The fire marshals arrived around 12:00 PM. The fire department commenced an inspection of all exits in the facility. An individual whom we understand is a safety manager, Mario Rodas, told the fire department, in the presence of Perez, that the dispatch door had been screwed shut because it was not working. However, Perez had used the door without issue the previous evening, and after the plate was removed, the door appeared to function properly.

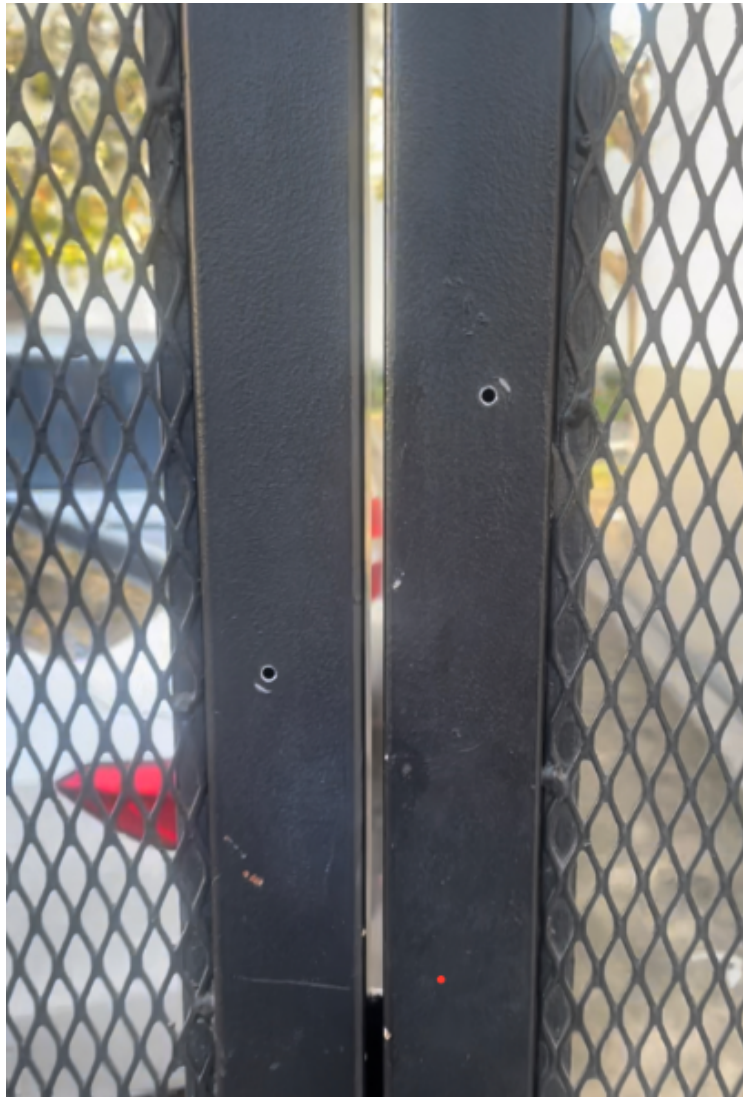
Employees have identified other exits that they believe were obstructed. On or around 6:40 AM on February 2nd, Andrade attempted to exit for his break using an outdoor gate that led to Hillcrest Boulevard. He was unable to open the door and observed that it was bolted shut with a metal plate. A security guard told Andrade that the gate was out of order. Andrade had to wait for a security guard to open a different gate that is normally reserved for trucks. The closest exits from Andrade's work station are the aforementioned gate and the dispatch door.

Perez and others later inspected the Hillcrest gate. Holes with a pattern similar to the holes in the dispatch door were evident. A photograph taken by Perez is below:
